ADVANCED GAS TURBINE (AGT) POWERTRAIN SYSTEM DEVELOPMENT FOR AUTOMOTIVE APPLICATIONS

FOURTH SEMIANNUAL PROGRESS REPORT
(JULY 1981 — DECEMBER 1981)

Engineering Staff of
Garrett Turbine Engine Company
A Division of The Garrett Corporation

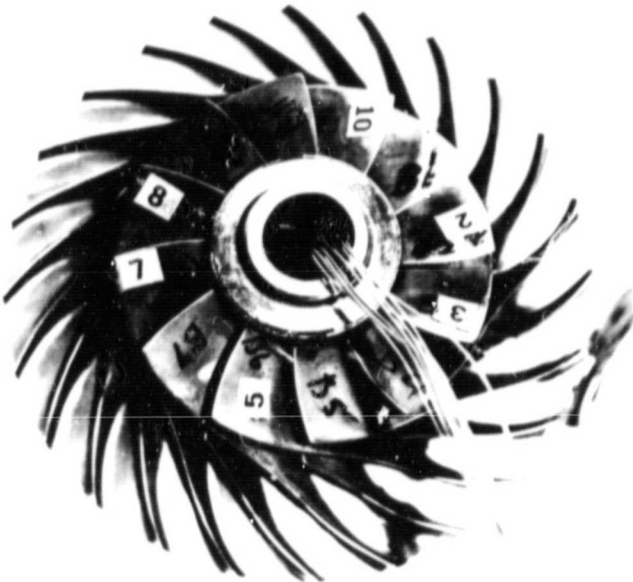
Figure 14. Strain Gauged Impeller, Front View.

The titanium impeller was instrumented with 10 strain gauges. Placement was based on holographic and acoustic test results. Gauges were placed on full and splitter blades with two gauges on the impeller backface. Figures 14 through 16 show the strain gauged impeller prior to test. Figure 17 shows the compressor rig in the test facility with the slip ring assembly installed.

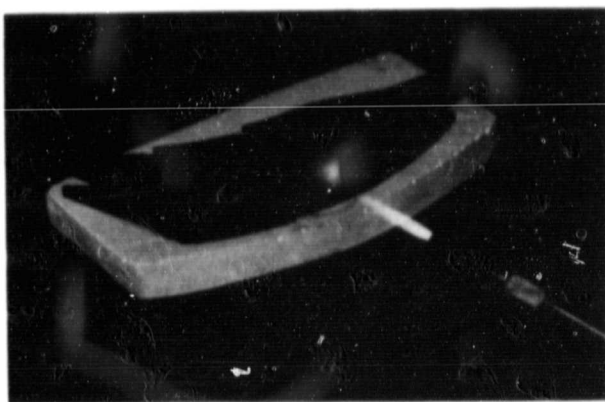
Figure 49. Carborundum α -SiC Stator Vanes in the Thermal Shock Test Rig (Left) and After Testing (Right).

Figure 49 shows Carborundum α -SiC vanes in the thermal shock rig and after testing. For illustrative purposes, the top of the specimen holder has been removed and only one torch is

in place. The results with α -SiC were similar to those for RBSN. Some vanes survived both Cycles A and B, indicating that the design and material properties are acceptable for the AGT101 engine. As was the case for RBSN, some SiC vanes fractured at the trailing edge mold line at the radius between the trailing edge and platform. This is being further investigated and is not expected to be a difficult problem to resolve.

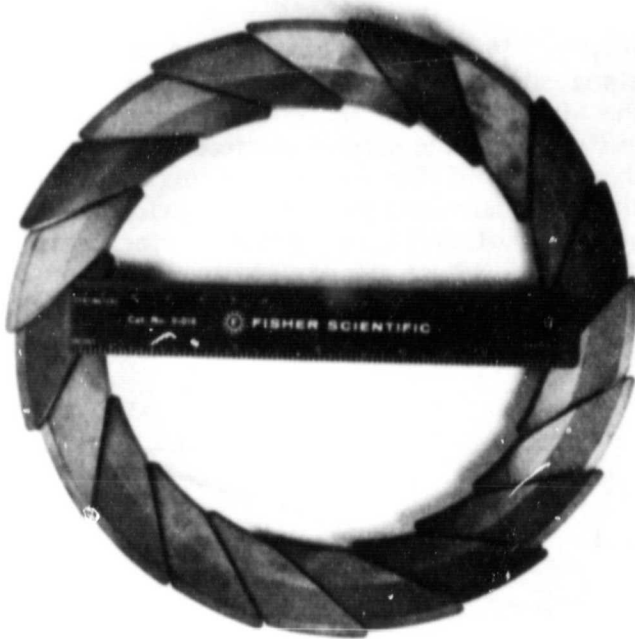
Figure 76. Stator Assembly Before Machining.

Grinding methodology is being developed utilizing the undersize sintered segments. An example of an unground set of 19 segments is shown in Figure 76, and an example of a ground and as-fired segment is shown in Figure 77.
